MERRIWEATHER POST PAVILION PHYSICAL REVIEW UPDATE

February 2014

ZIGER/SNEAD

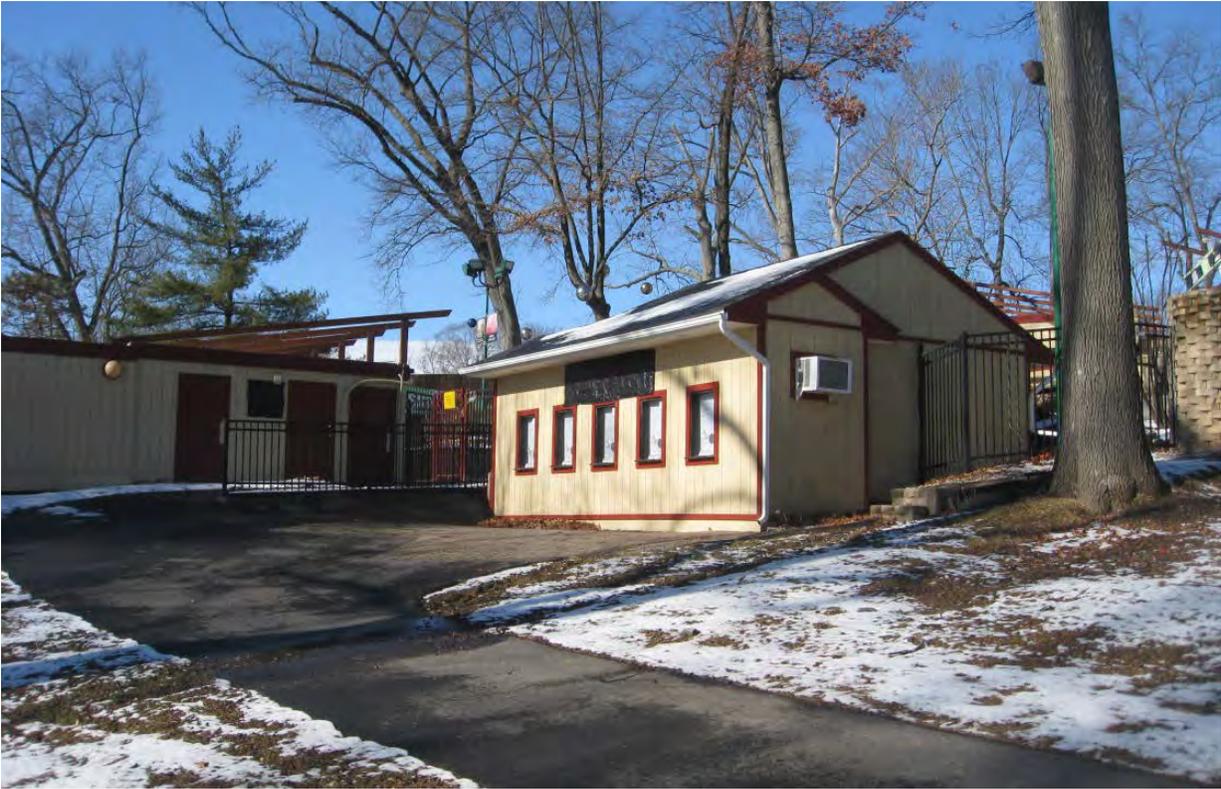
Elevated and re-roofed South Box Office with dilapidated South Restrooms beyond.

The newly constructed replacement West Box Office, though a bland aesthetic statement, is now suitable for long term services if needed. The recently raised and re-covered East Box Office continues to suffer from severe water infiltration at its foundation and a sump pump is still required to maintain its function. The location of the Box Office adjacent to the south entrance gate requires that to purchase tickets there in advance of a show, patrons must make the 5 minute woodland round trip on foot; a inconvenience that the Operator has identified as undesirable.

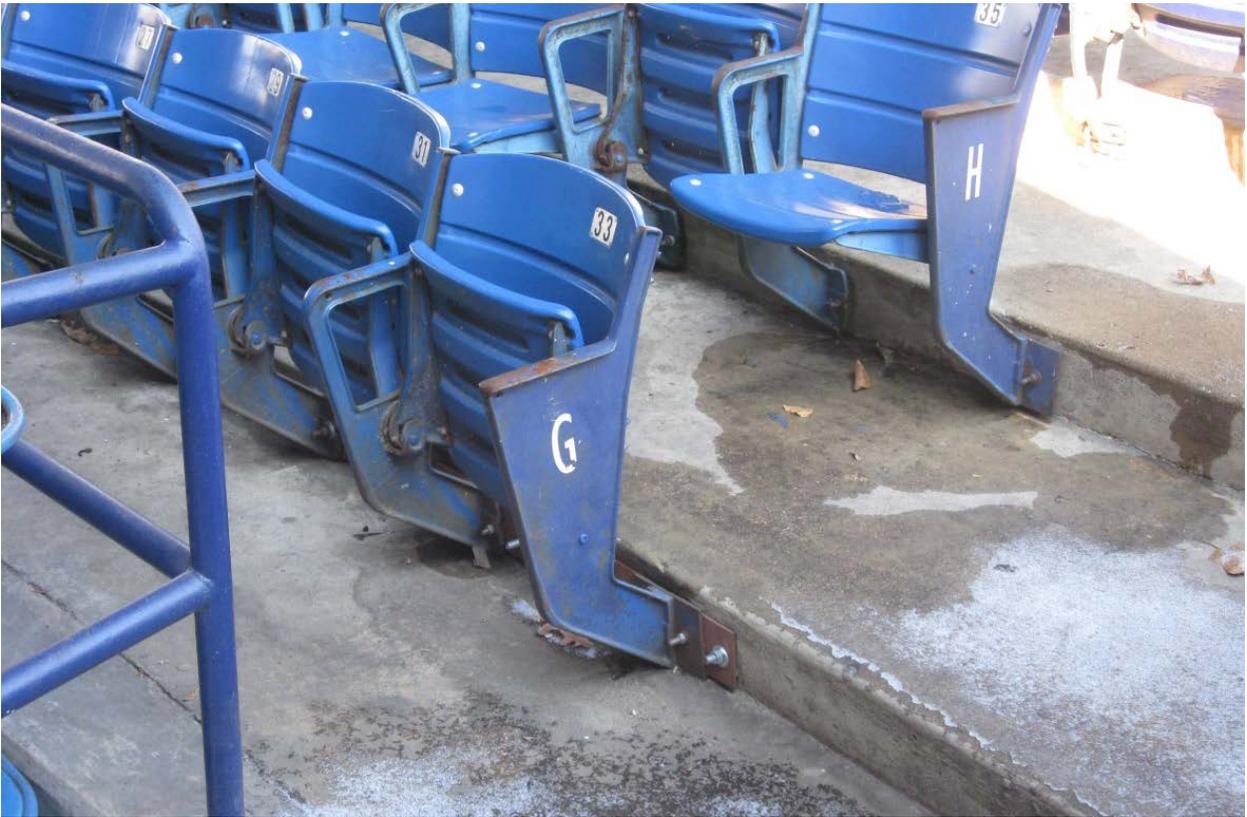
Replacement parts for original riser-mounted cast iron seating have run out.

- F. Replace and Reconfigure Seating Base: Remove deteriorating, access-restricted stepped concrete slab and replace with new, configured to provide safe and convenient access and egress, solid seating anchorage, and more varied viewing options including more evenly distributed ADA seating. Modify subgrade as necessary; install new underground utilities, safety railings, and step lighting as required. Repair existing concrete foundations. Install 3,650 new arena-type fixed seats.

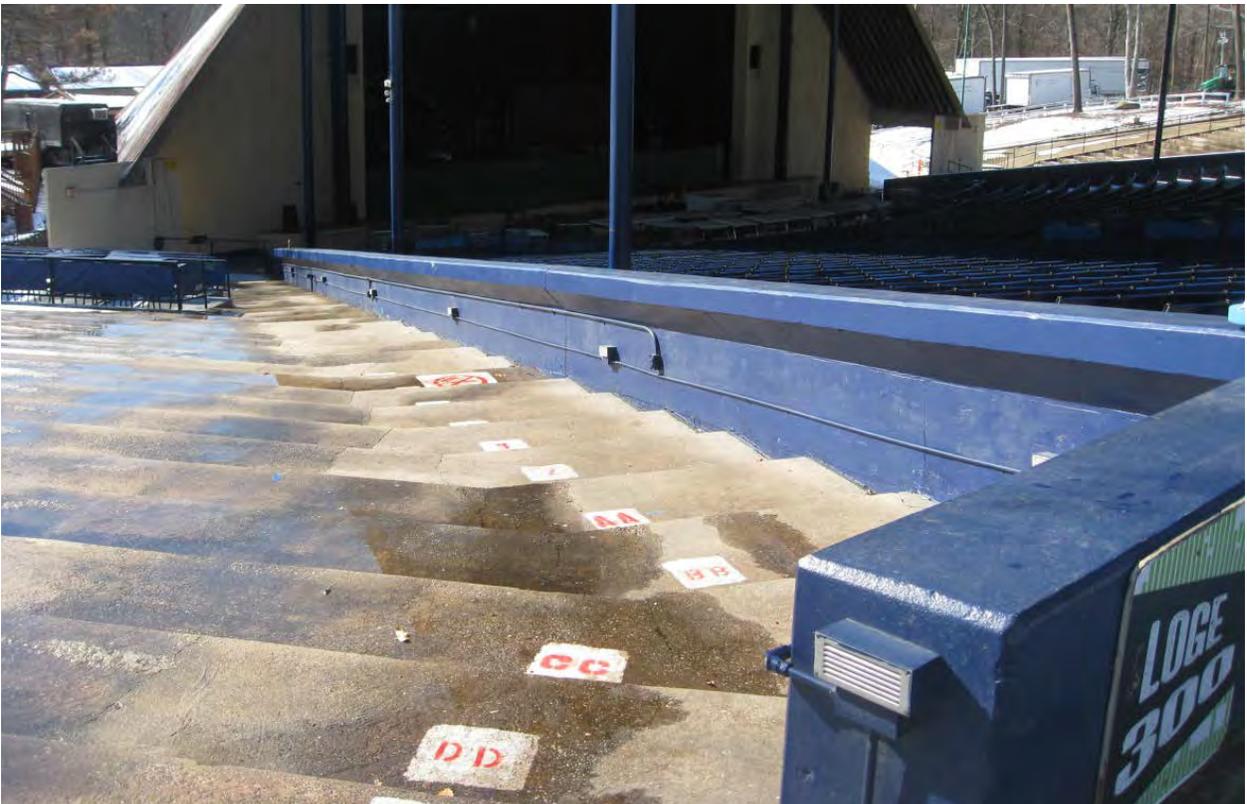
Original concrete cheek wall between original and newer Loge seating obstructs ingress/egress.

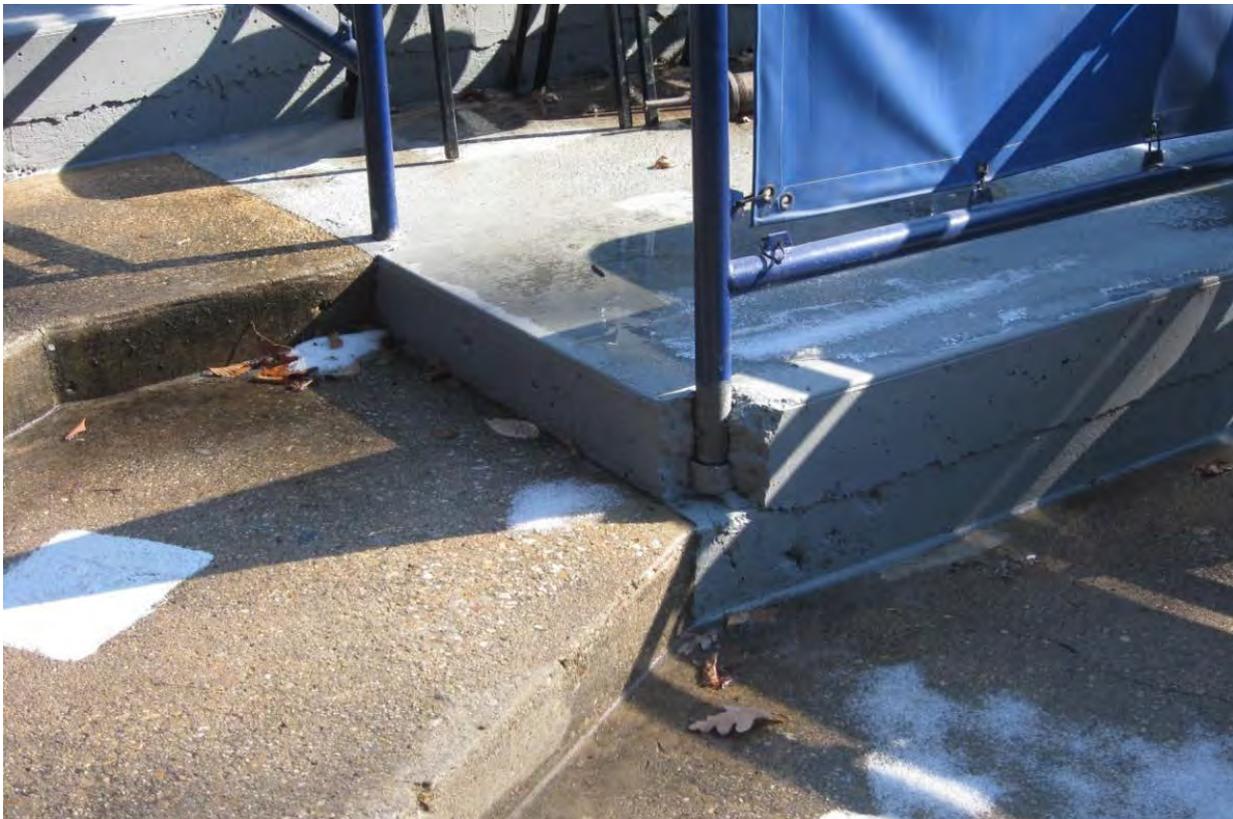
Characteristic concrete deterioration at Pavilion seating base, east side.

Covered Seating Risers: The concrete riser slabs which underlie the reserved seating areas are problematic from a number of perspectives including deterioration/settlement, restricted ADA accessibility, and, more recently, emergency egress. Subjected to 30 years of use, yearly freeze-thaw cycles, and full rain/ice weathering near the shed's perimeters, the slabs are experiencing areas of spalling, cracking, and general wear. Riser mounted seats anchored to the slab occasionally work loose and require substrate repairs and reinstallation. Though concrete's deterioration raises a parallel question of a configuration with safety issues and large inaccessible sections. Constructed in 1967 the seating layout of the Merriweather Post Pavilion lacks both handrails and the more broad distribution of available seating now required by law for accommodation of the disabled in new performance facilities. Although the small area of dedicated H/C accessible seating presently exists in the west Loge, and both the front and rear of the reserved seating areas are accessible, there is no location at the center of the amphitheatre that is configured for handicapped accessibility. And the number of accessible seats required by the ADA for accommodation far exceeds the number currently dedicated. The creation of the flat GA Deck at the front of the House has added approximately 650 occupants at that location, and emergency egress has become more constricted as a result.

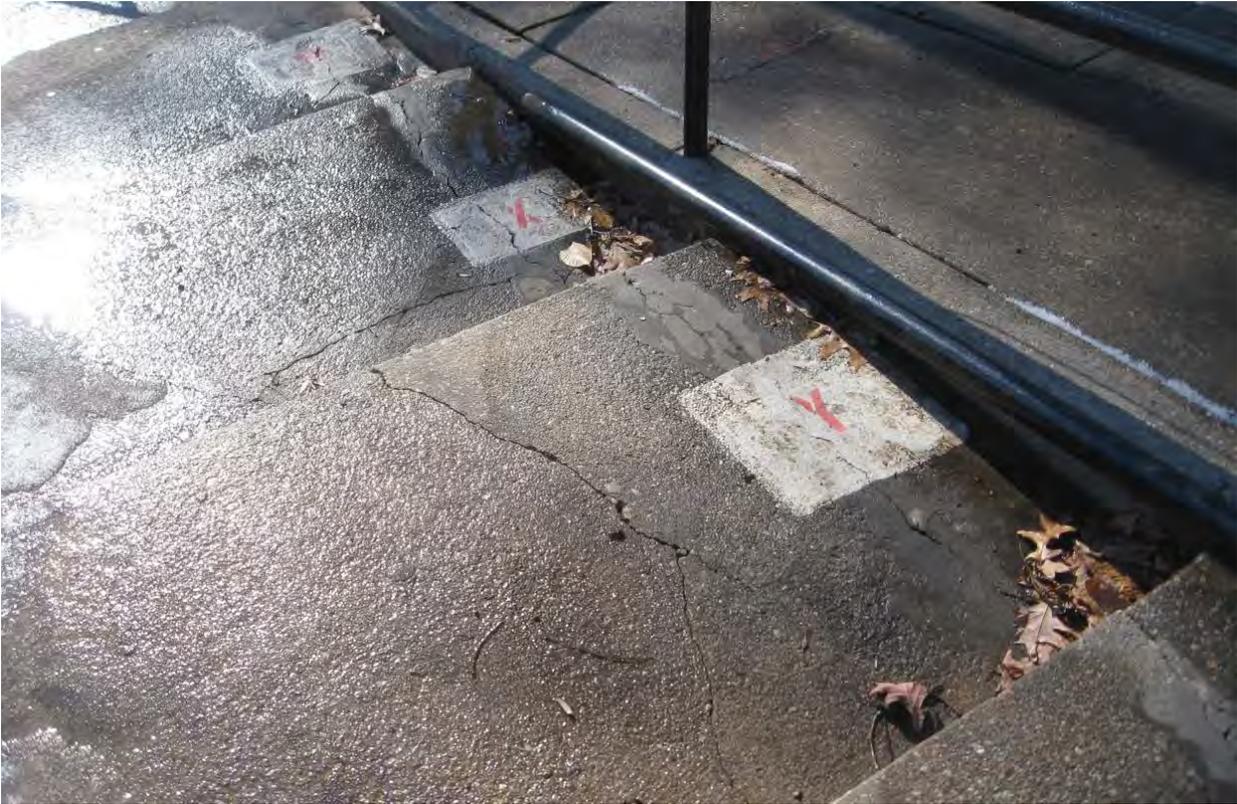
Characteristic settlement cracking East Loge seating base.

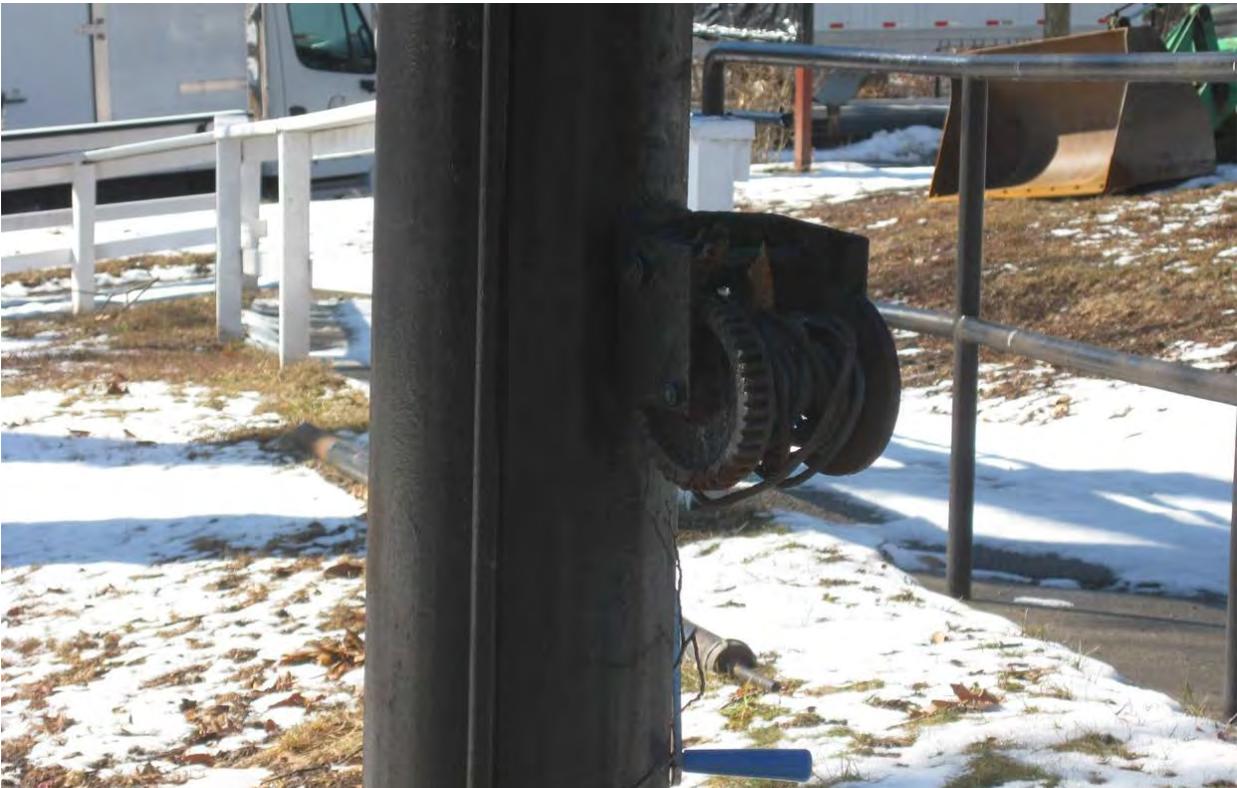
Failing winch hardware at Loge tent masts has required replacement as needed.

The Loge tents have become maintenance headaches, particularly as the performance season has extended at each end into April and October. Periodic replacement of the tents due to wear and tear including snow damage has become a significant operating expense. The painted metal folding chairs are also at the end of their life and either refurbishment or replacement is essential.

- E. Replace Temporary Loge Tents with Permanent Roof: Eliminate complex, maintenance-intensive assemblies of canvas, guy wires, and posts and replace with substantial roof structure visually compatible with existing. Install LED house lighting and fans matching the existing House. Install dry sprinkler system.

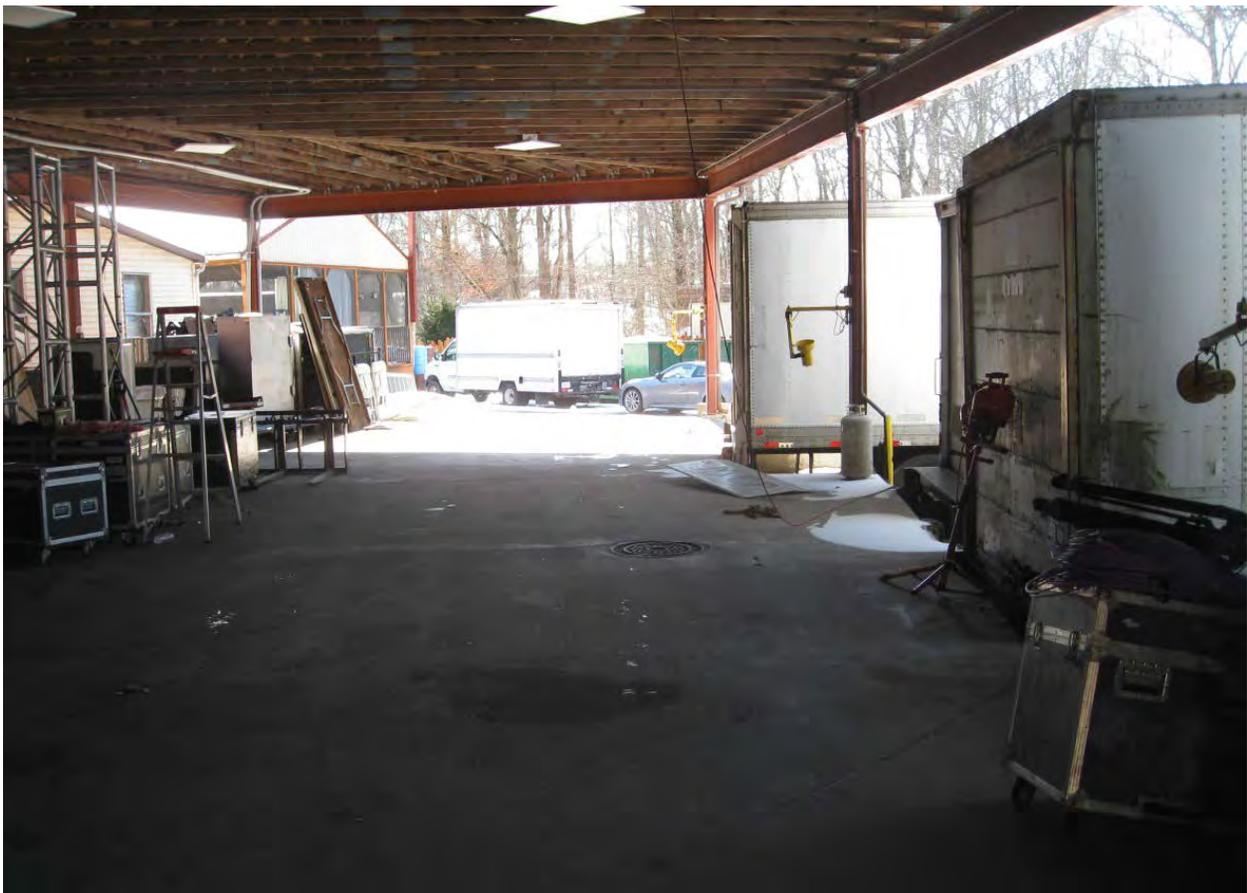
Loading Dock suitably supports six trailers but requires additional shore power for buses.

The 1997 modifications to the dock area greatly improved conditions for loading shows in and out. Up to 4 large trailers can simultaneously unload under cover with space on the dock for temporary laydown with 6 trucks accommodated on occasion. The existing 60 Amp shore power panel at the Loading Area is said by the operator to be undersized.

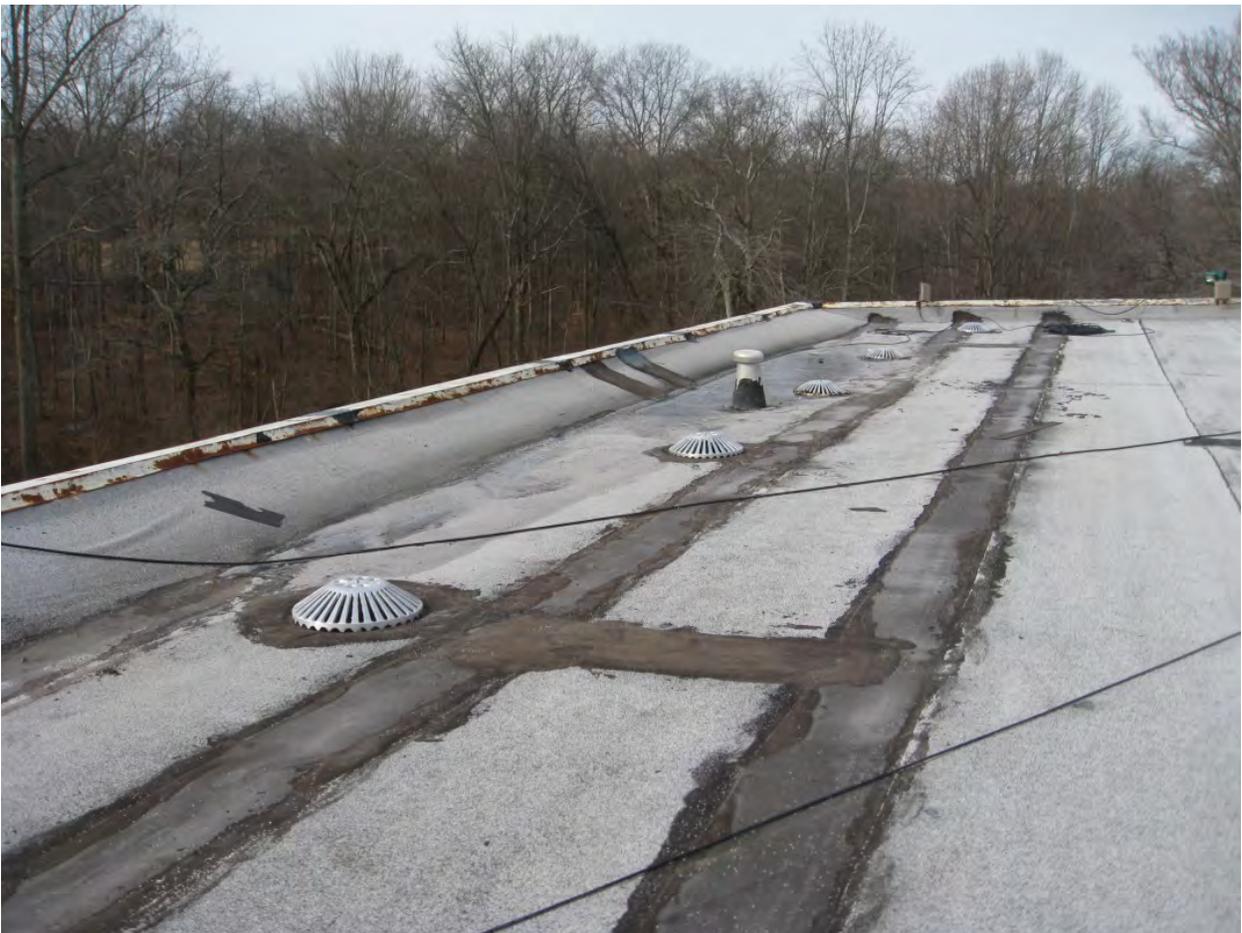
View of Pavilion roof above rear of stage. Roof, flashings and drains are now in need of replacement.

to support soft area of planking as they become apparent. The roof drains located above the lower stage portion of the roof are original and show evidence of numerous repairs. The fiberglass shingles on the saddlebag perimeter of the stagehouse remain in need replacement as reported in the earlier investigation. All roofing and flashings should now be replaced. Similarly, the original rough sawn board enclosure around the perimeter of the roof has deteriorated over time and become riddled with holes from boring bees. Daylight now shines clearly through the gapped joints between boards and through the bug holes. Asphalt felts applied to the inside face of the boards above the stage at some time in the past to stop driving rains are now torn and ineffective. The seasonal Loge tents remain a poor long term solution for weather cover to the side seating as reported in 2004. Costly to install, dismantle and maintain on a yearly basis, these canvas awnings have served only as a perpetually temporary solution. The guy cables stabilizing the temporary masts impede circulation at ground level, and the fixed masts installed to support the inside edge of each Loge tent, four on each side, obstruct views from the Loge seating.

As stated above, the roofing and enclosure above the stagehouse are now in need of replacement. As visiting performers continue to stage increasingly elaborate shows the facility must be verifiably up to the task of supporting them.

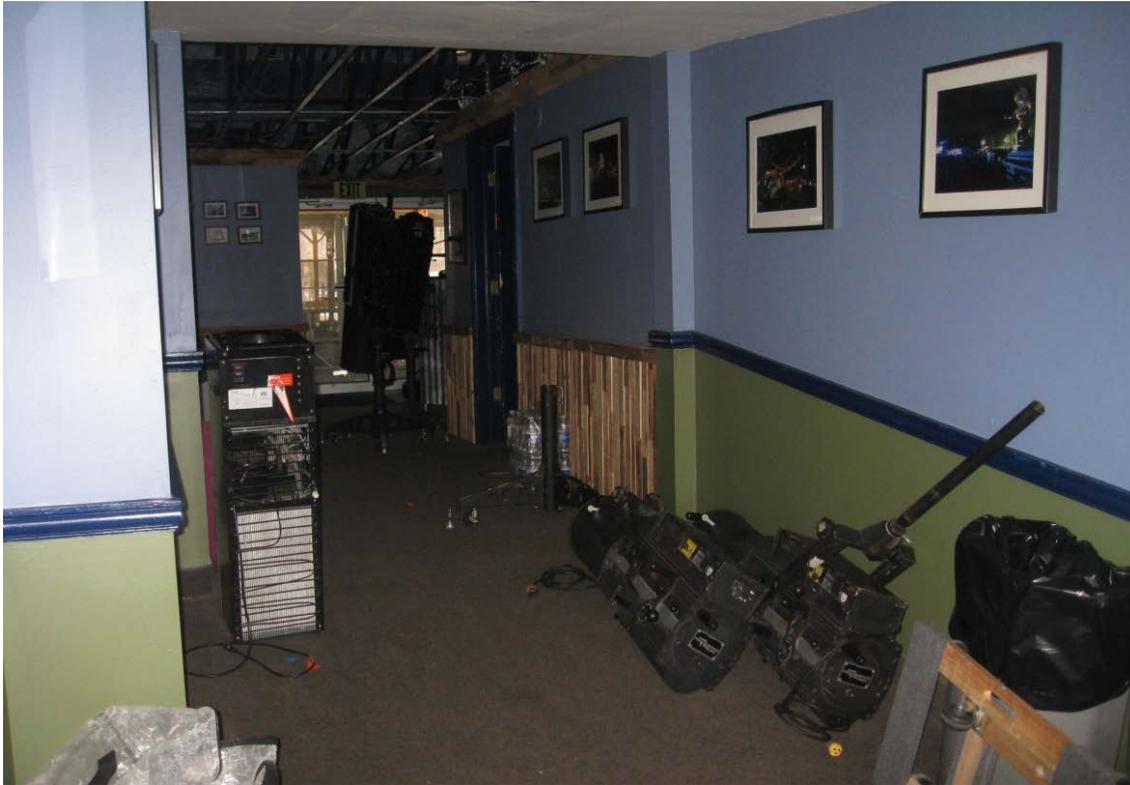
Most performer Dressing remains in modular building. Entire floor deck has been replaced.

structural integrity, temperature control, and finish continuity. The entire plywood floor deck in the modular assembly had to be replaced recently. As described earlier, the Operator has recently added five new dressing suits in the form of two trailers situated on the south side of the rear service drive. An additional fifteen dressing suites are occasionally necessary. As recommended in 2004, the present dressing facilities should be replaced with a permanent addition, now accommodating at least ten dressing suites.

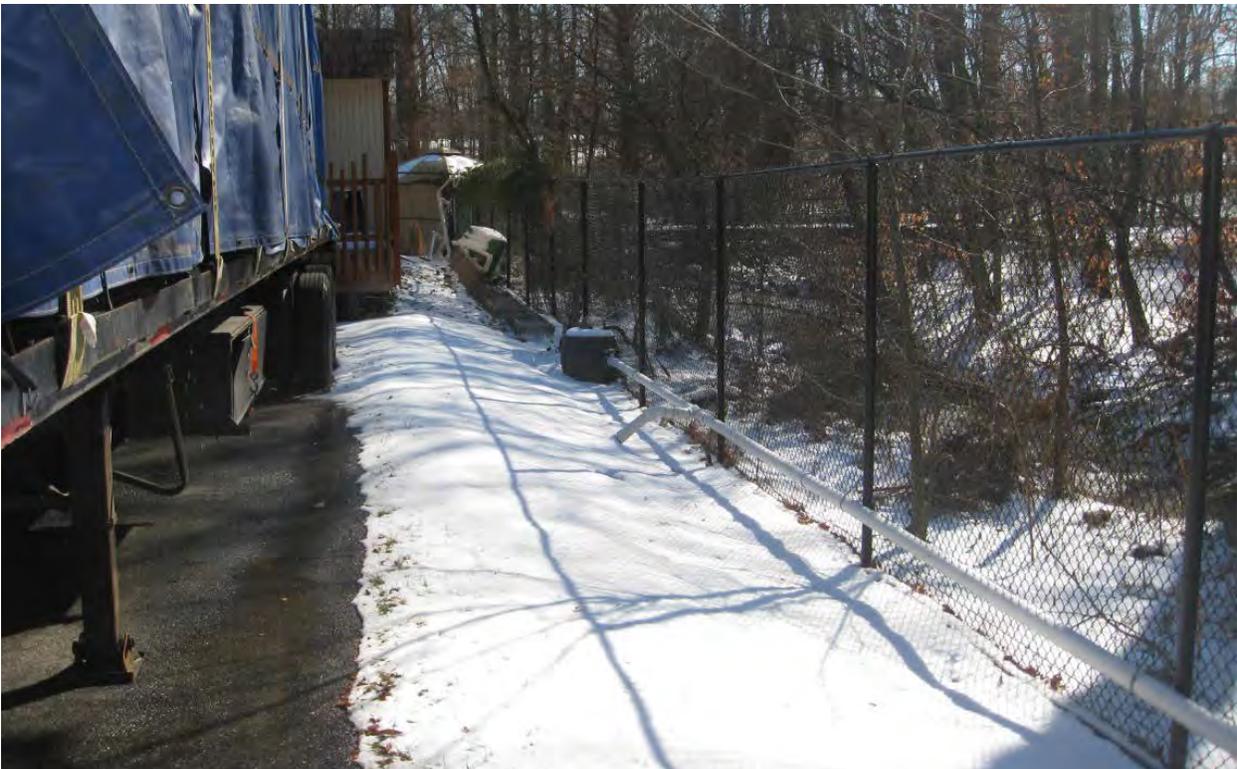
Temporary above-ground plumbing provisions for four additional Dressing trailers.

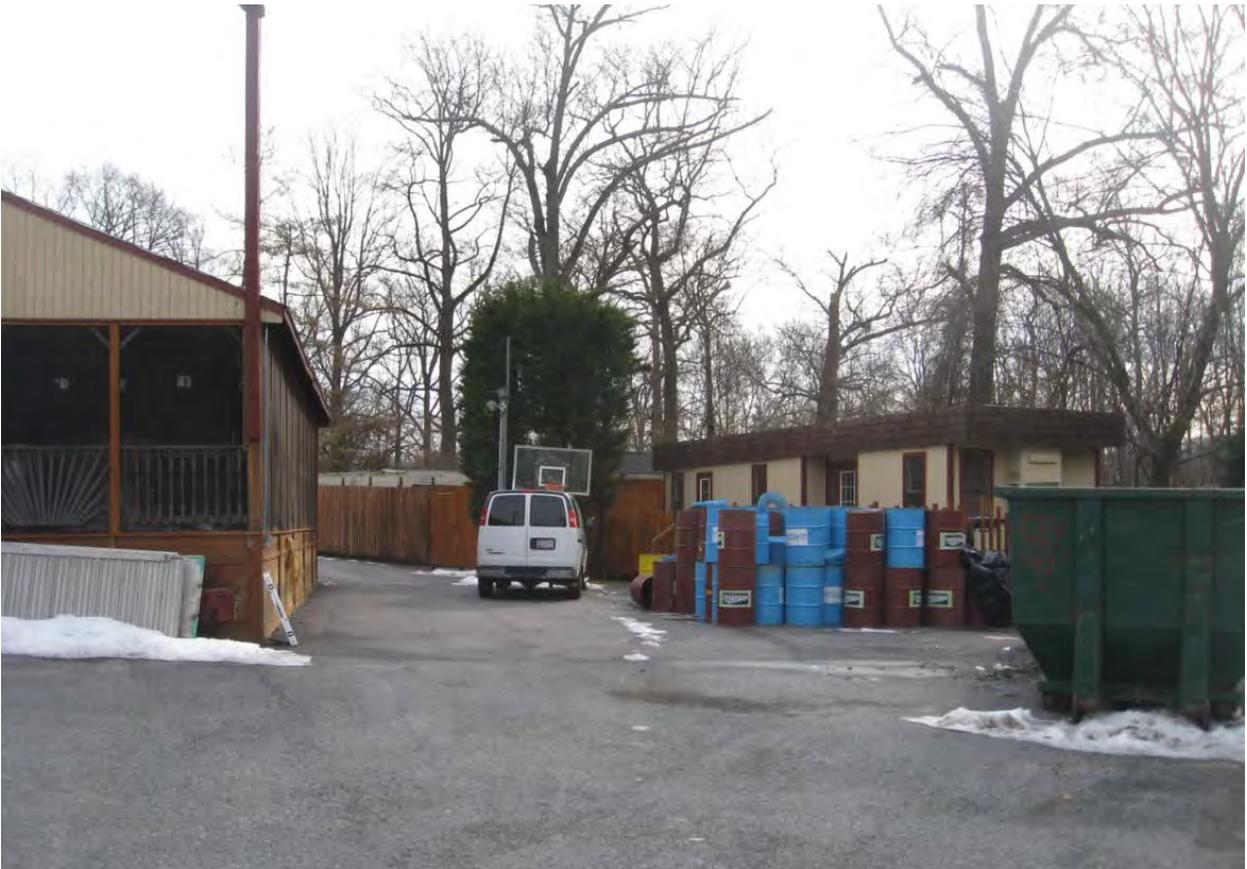
Access to rear of Pavilion is now more cramped for both service and emergency vehicles.

Performer Parking: Due the continued expansion of loosely spaced backstage facilities as well as the obstruction presented by a number of storage trailers, performer parking is now even tighter than in 2004. Parking for artist buses, formerly accommodated along the south fence line, is now occasionally blocked by the added performer dressing trailers. A concept plan by the Operator to expand bus parking over the 100 year flood plain has so far been unaccepted by Howard County authorities.

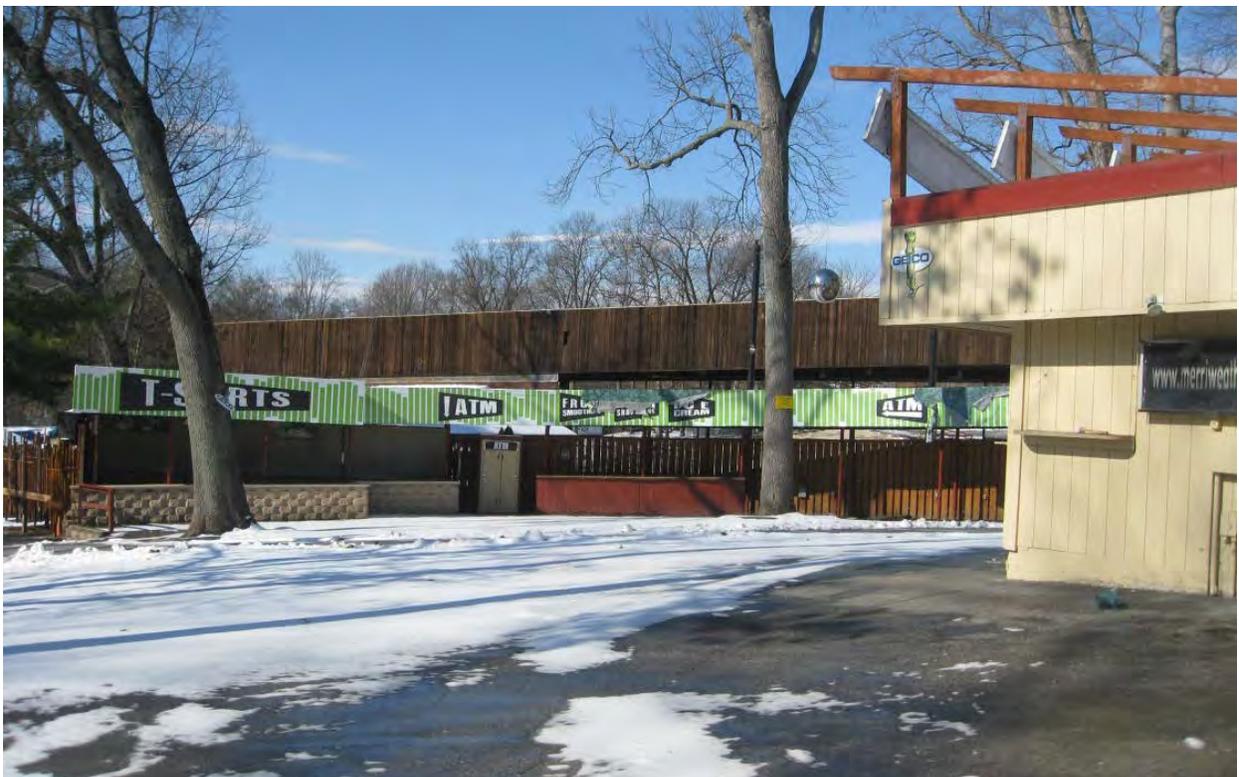
South Plaza Food and Merchandizing Concessions. Paving has steep cross slope.

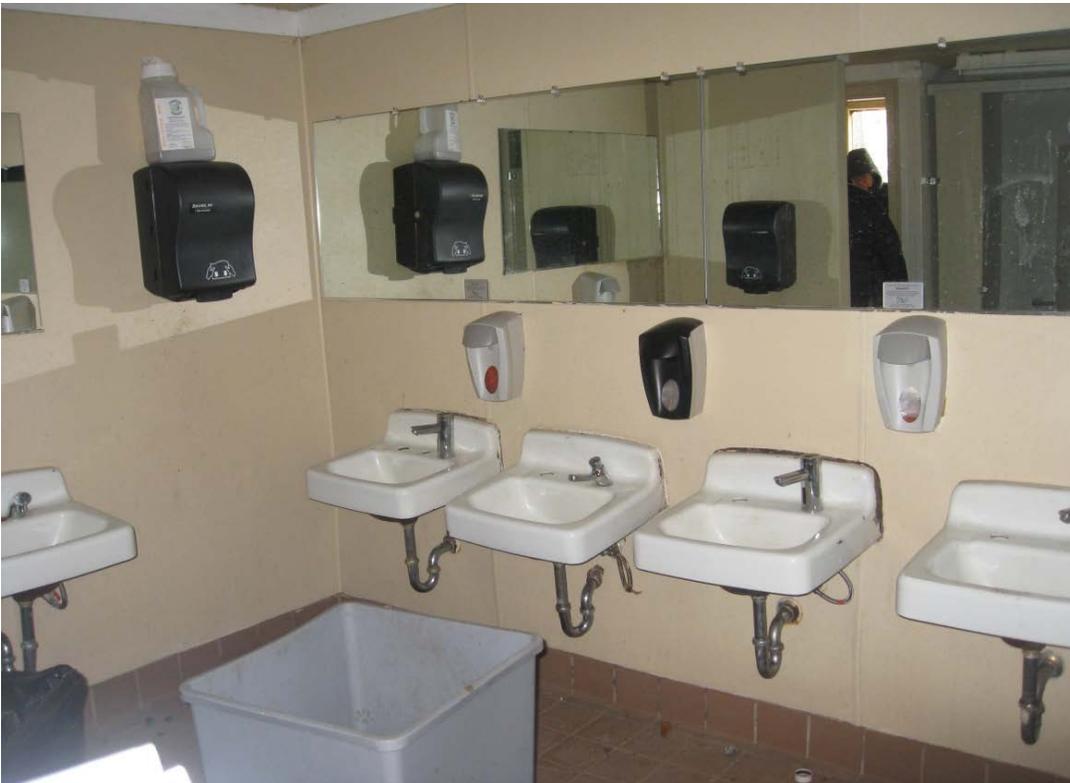
East Restrooms remain cramped and deteriorated.

Most critical currently are problems with public restrooms as these have never been supplied with hot water, and they suffer from deterioration due to rot, mold, damaged finishes, and multiple plumbing failures stemming principally from freezing over the winter season. Periodic intrusion into attic areas by raccoon and other pests add to

maintenance headaches. The original West Restrooms are now used only sparingly as conditions there continue to worsen. All toilet rooms, believed to house approximately 105 toilet fixtures in total and almost equally split between males and female facilities, tend to be greatly over crowded, for female users in particular. As recommended in 2004, all older facilities should be completely replaced with expanded, fully code compliant structures as soon as possible.

- B. Replace Audience Restrooms: Demolish and replace three cramped, deteriorating existing facilities and replace with expanded, reconfigured code-compliant structures to provide safer, more convenient access as well as increased fixture counts including ADA accessible fixtures. Renovate two existing historic restroom facilities to the same criteria. Restore exterior of both historic structures as well as a third historic maintenance barn with new, painted wood siding and new painted metal roofing.

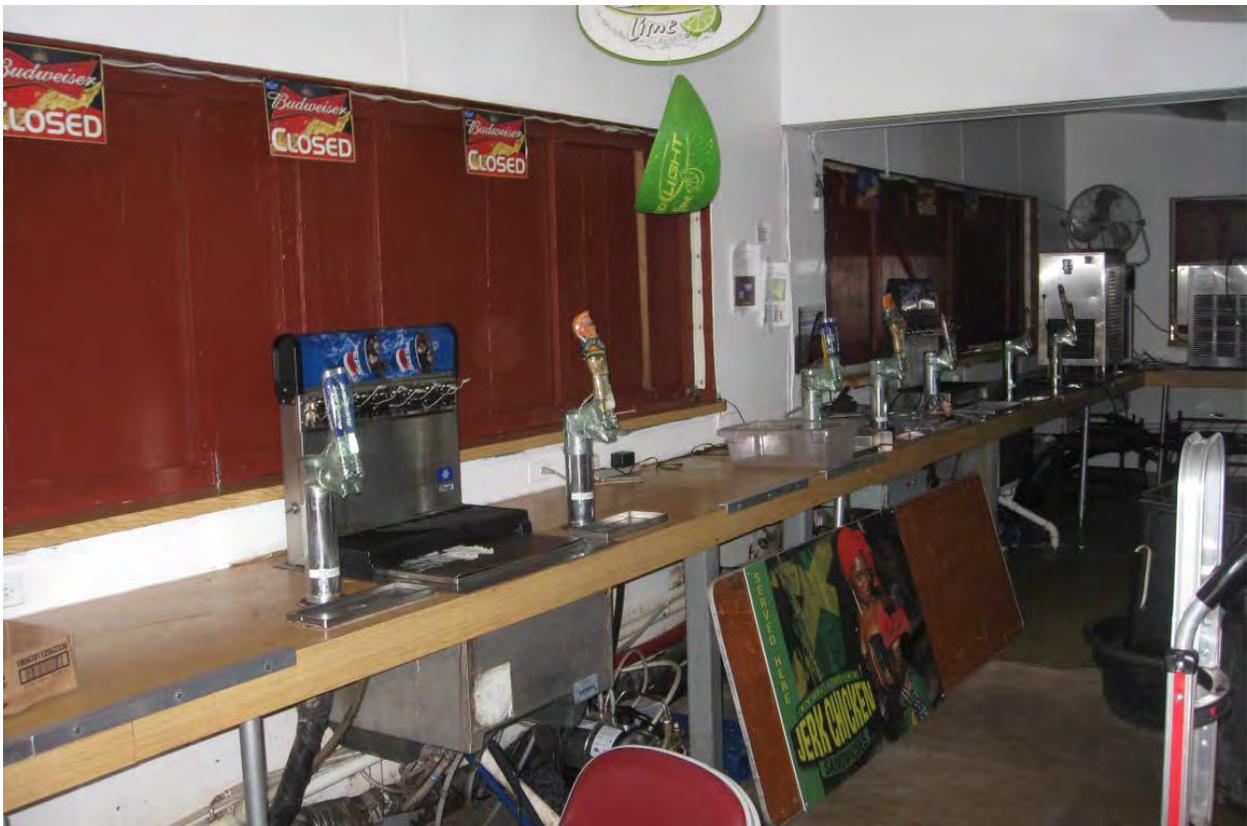
Interior of original Stand One Food Concession which requires constant repair

The original, permanently licensed food concession stands continue to cope with similar problems of deteriorating enclosure, a shortage of adequate electrical power, outdated kitchen equipment, and a pervasive lack of back-of-house support space for refrigeration units, trash containers, etc. Health Dept. officials have expressed concerns regarding these conditions including the shortage of screening, windows, or other means of limiting access to food by flying insects in the summer months. Insubstantial means of preventing passage of food grease into sanitary drains also was identified as a concern.

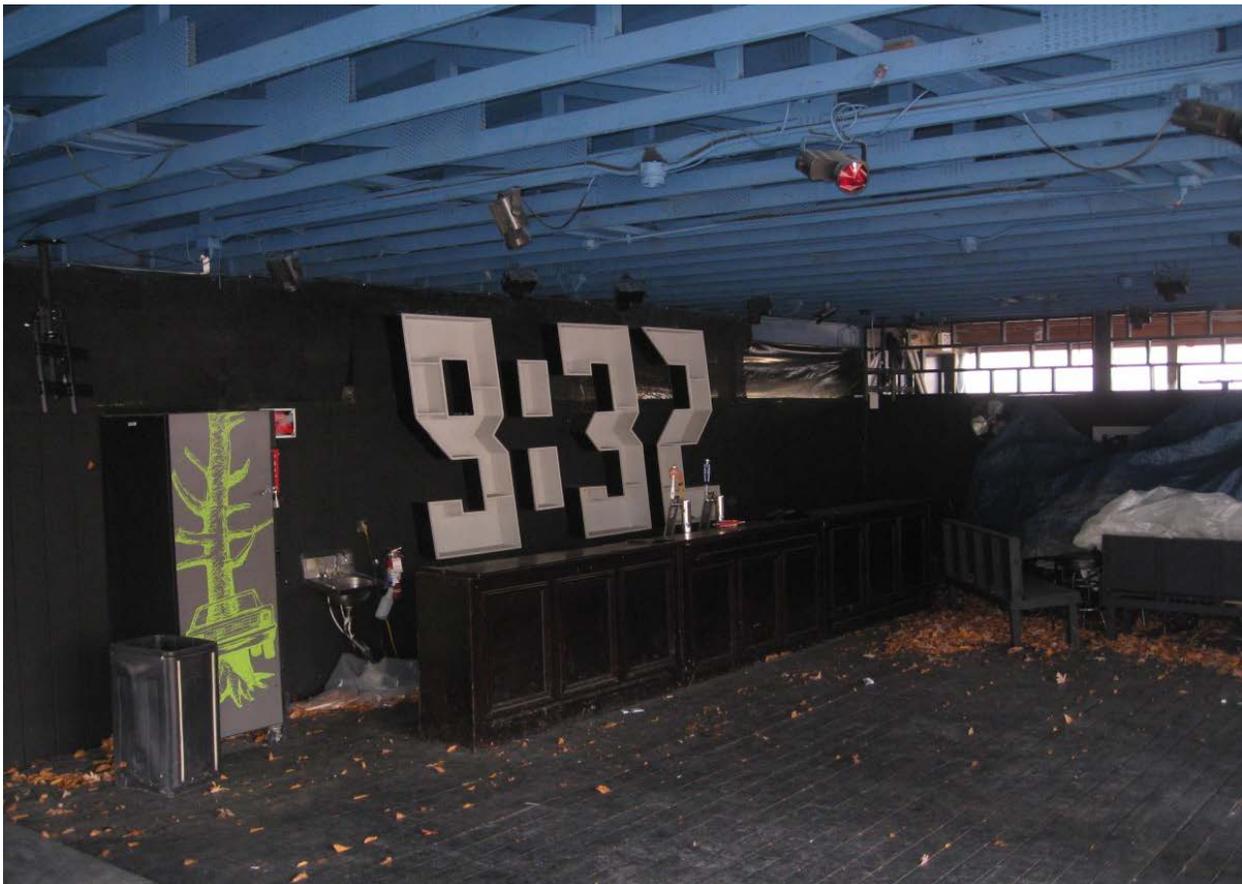
“932 Club,” an Assembly Occupancy, requires a seasonal food permit, and sprinklering is now advised

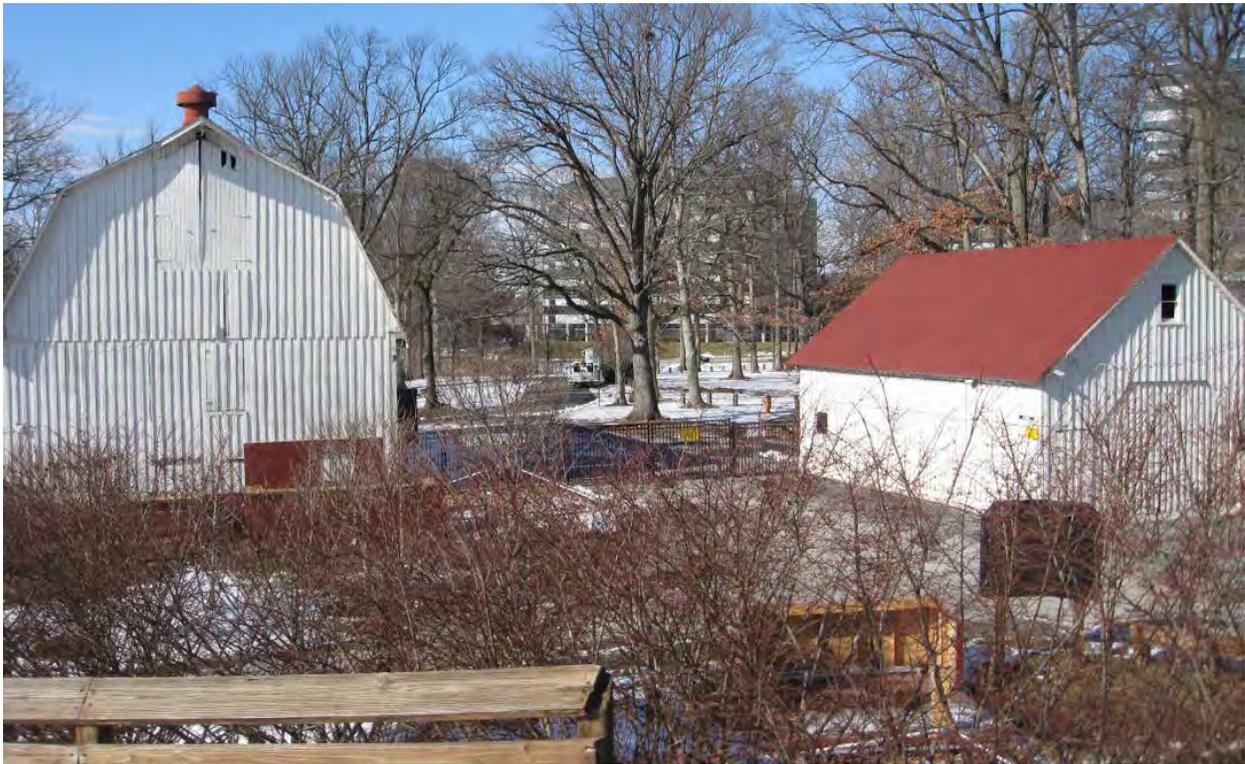
Public Restrooms in the Barn to the left are out of date and require remodeling complete with hot water.

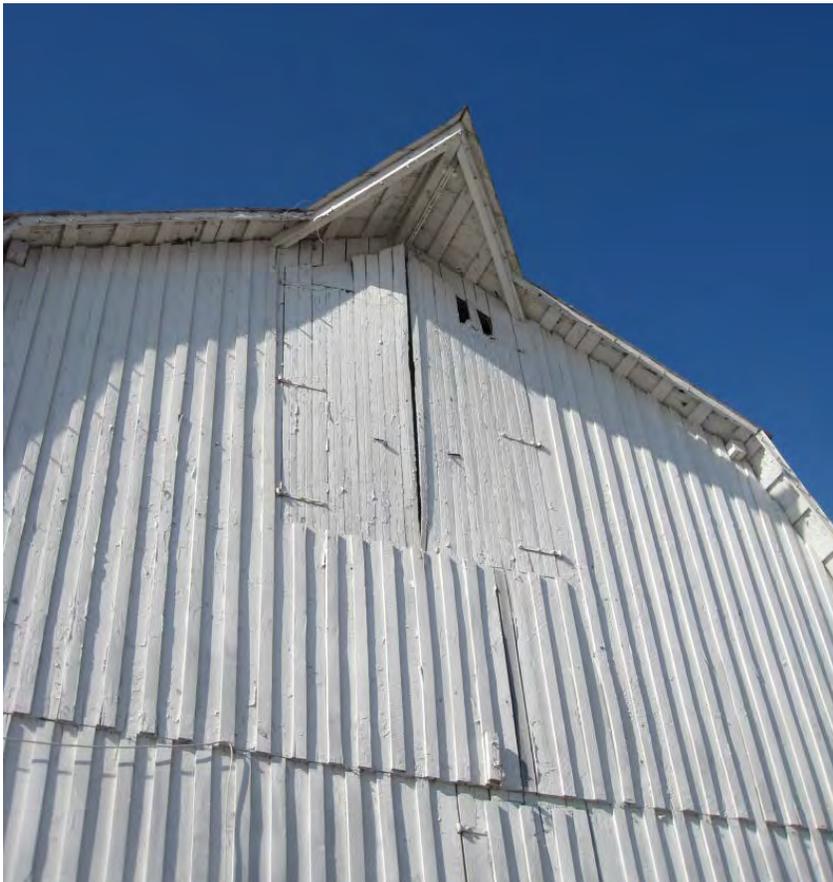
The exterior enclosures of all three historic structures require replacement with new siding and roofing.

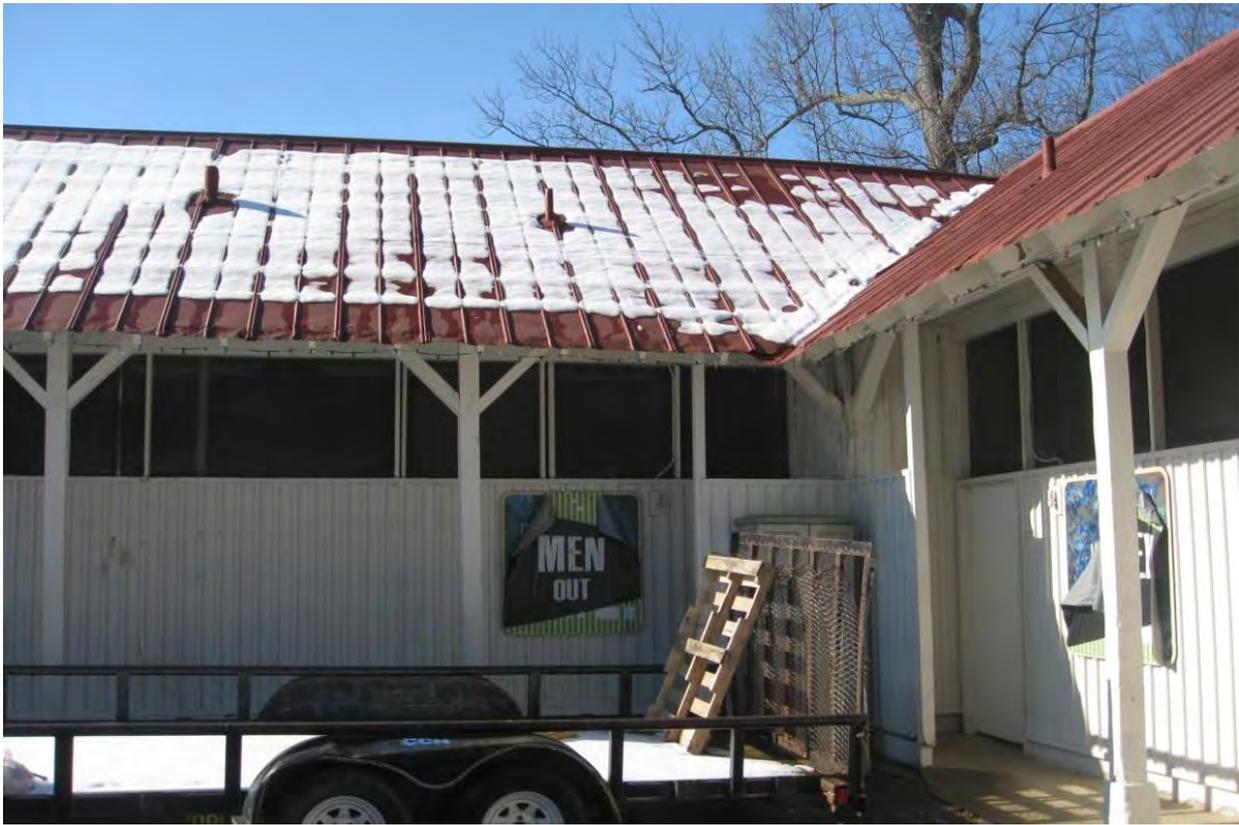
Restrooms in the “L-Barn” are outdated and require remodeling complete with hot water.

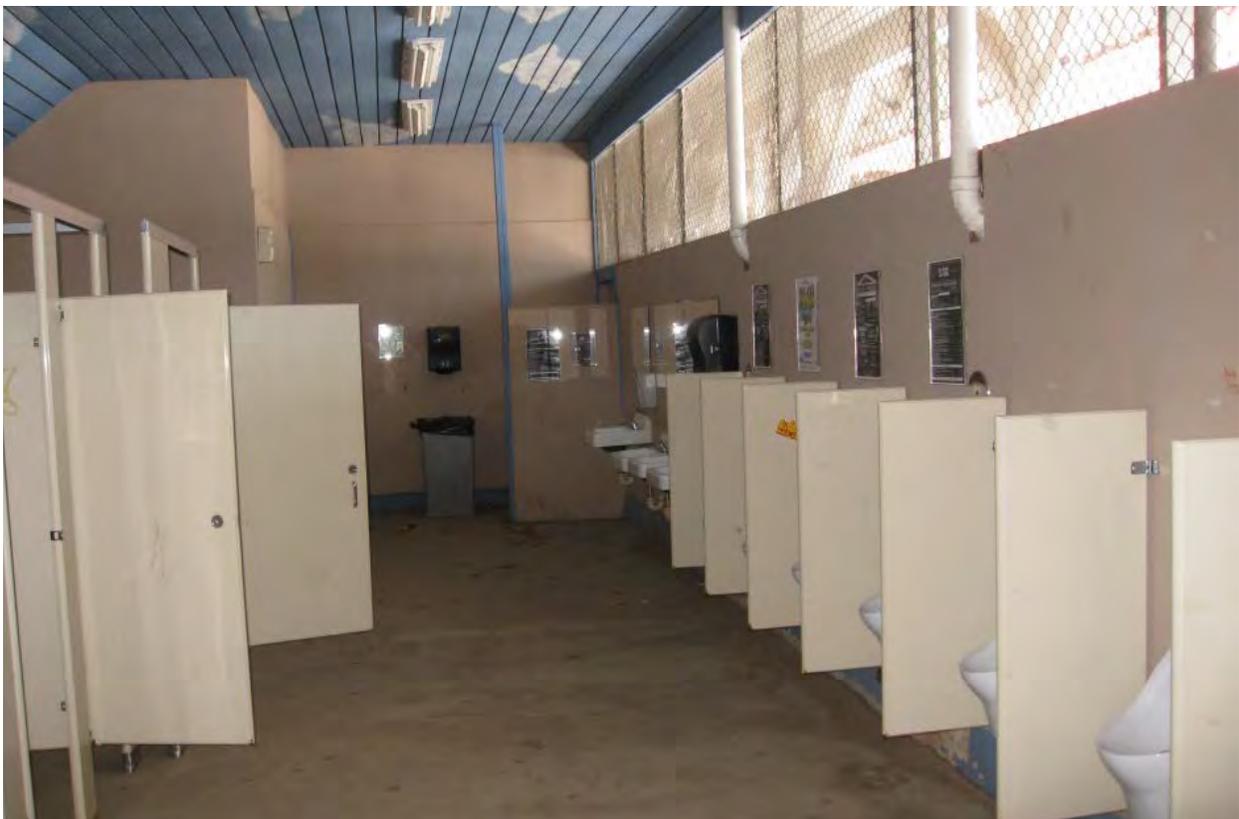
Interior of “L-Barn” Restrooms. These are adequately proportioned but inaccessible and out of date.

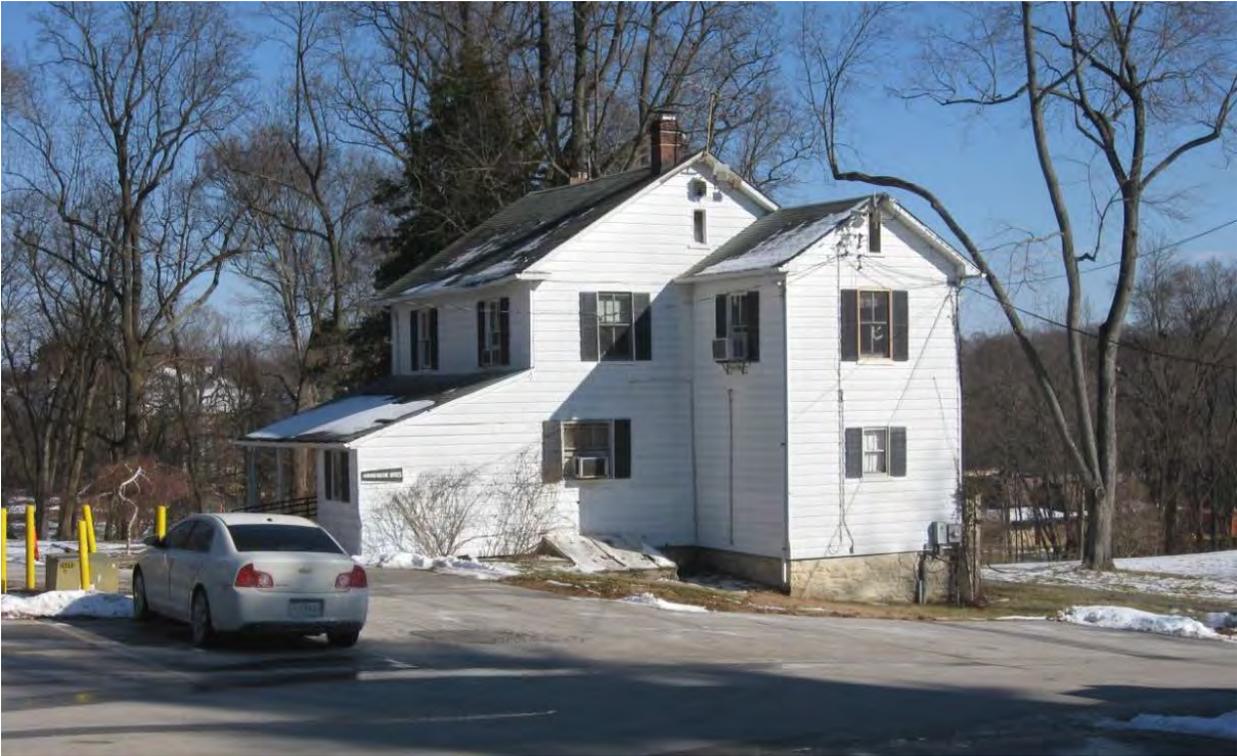
Administration remains in the historic house but is seriously under sized to serve the maintenance-intensive, year- round operation of the pavilion.

The historic farmhouse currently housing the Operator's offices continues to experience all the maintenance issues normally associated with an aging residence. In 2004 the Operator identified replacement of the single gazed, double hung windows with a more thermally efficient model for better energy performance as their highest priority for the structure. Central air-conditioning has now been added to the wish list.

- J. Replace Windows in Administration Building
